**Doylestown Township Pollutant Reduction Plan/TMDL Plan
Attachment D-2 - Structural BMPs to be Utilized to Reduce Existing Loading**

Attachment E-1

Photographs – Selected BMPs

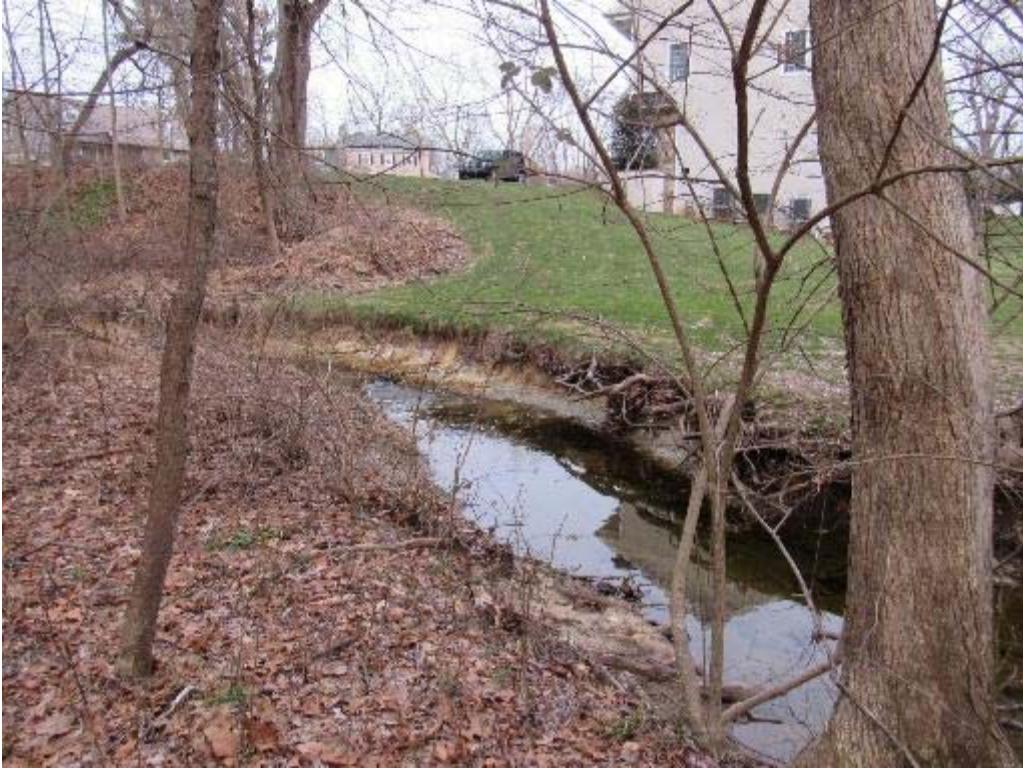
Photo 1 view of channel where land use changes from forest to residential and the east bank riparian zone is mowed.

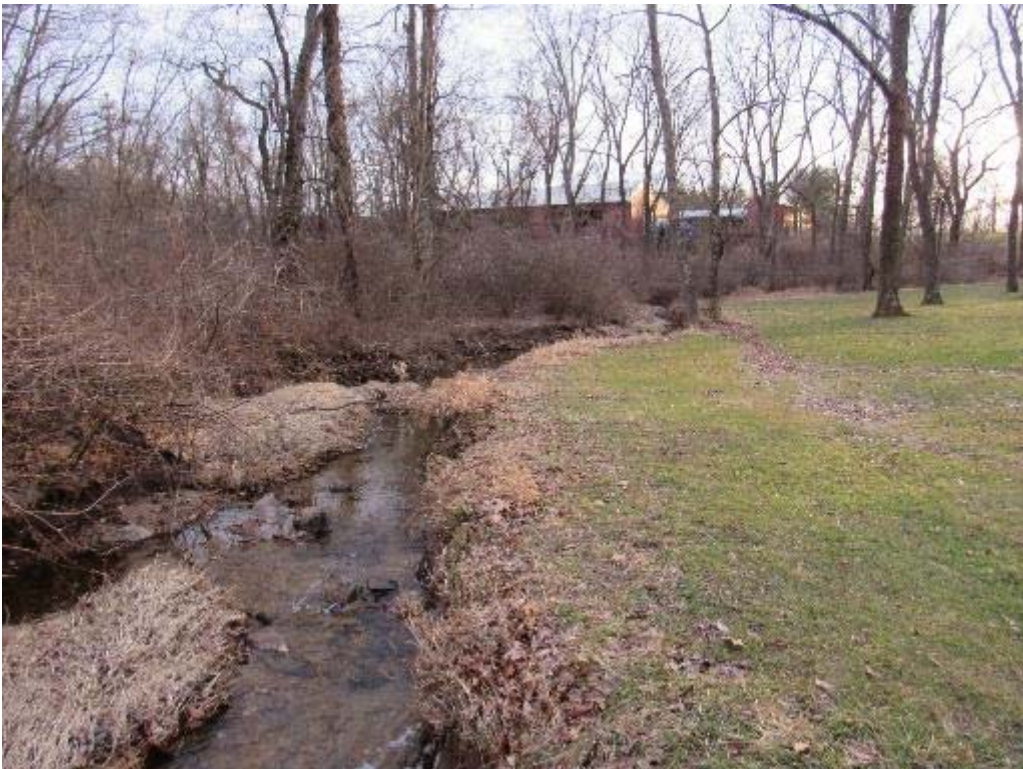
Photo 2 View looking downstream of Trail bridge crossing. The riparian zone on the west bank is grass and the east bank is primarily . Stream bank erosion is noted along with mid channel bar formation

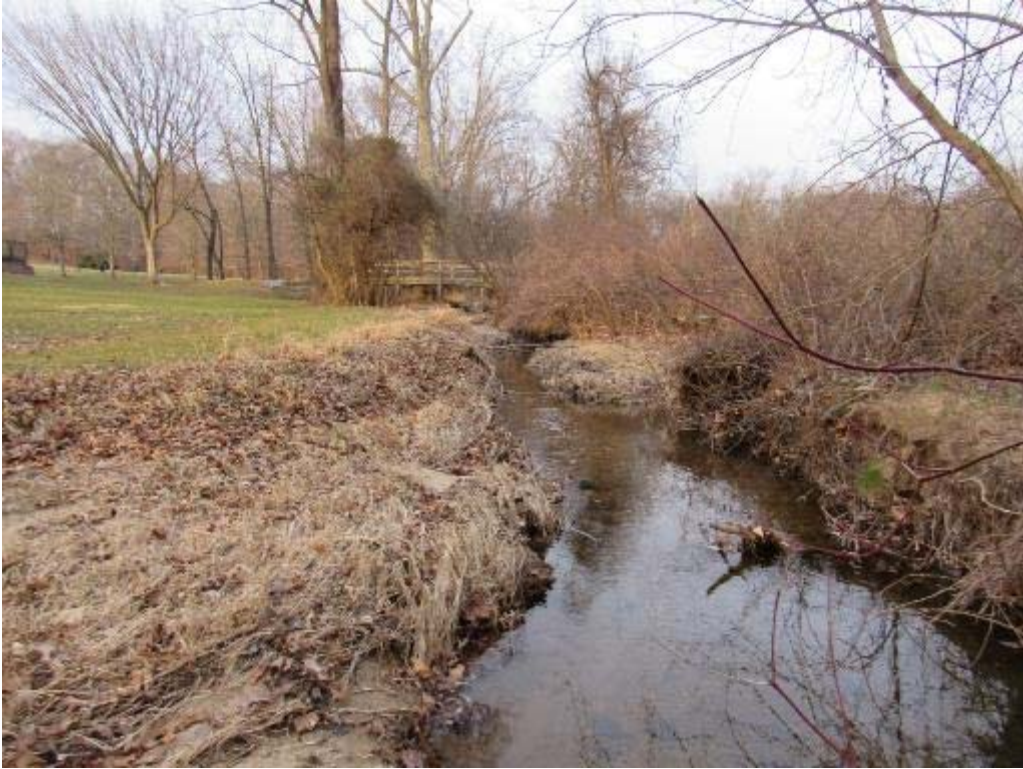
Photo 3 View looking upstream of Trail bridge crossing. Note vertical stream bank and erosion on the east bank and limited riparian vegetation.

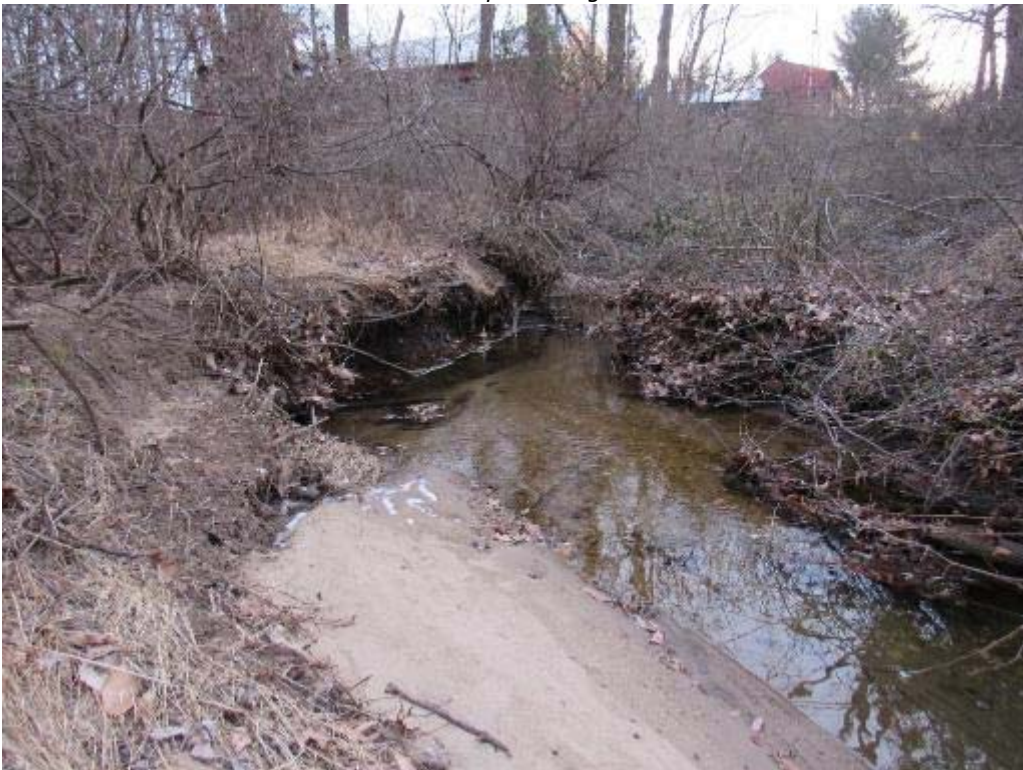
Photo 4 View looking downstream at undercut stream banks, fine grain sediment deposition and dense, shallow rooted invasive vegetation in riparian zone.

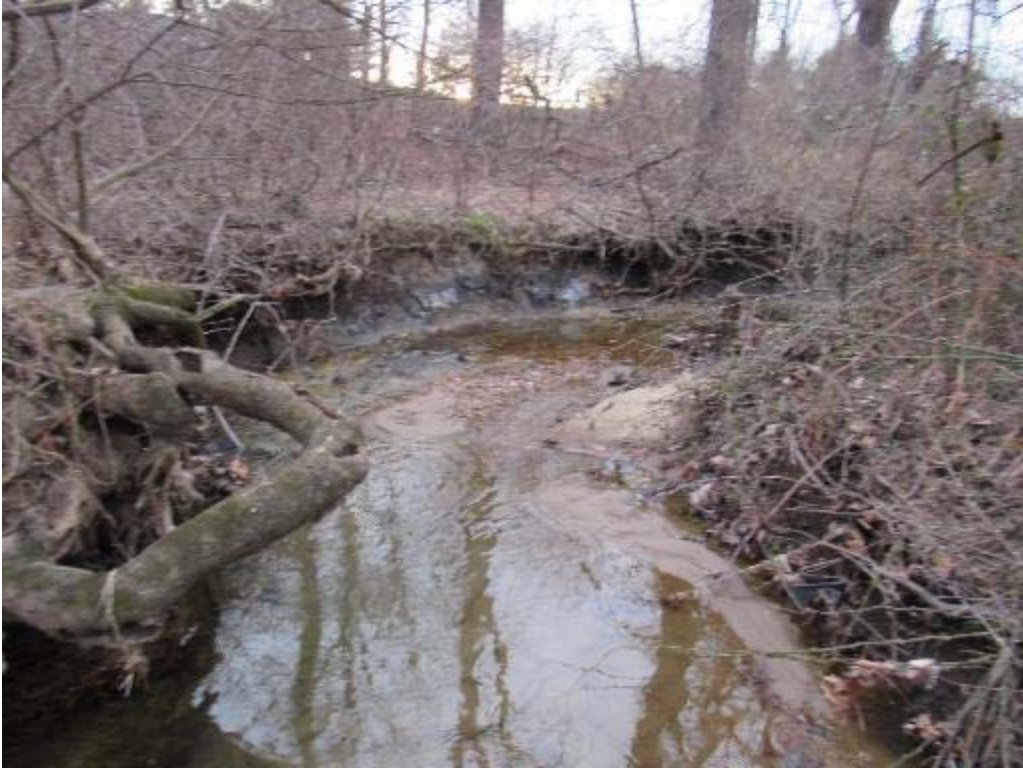
Photo 5 View looking downstream showing vertical eroded stream banks and mid channel bar formation.

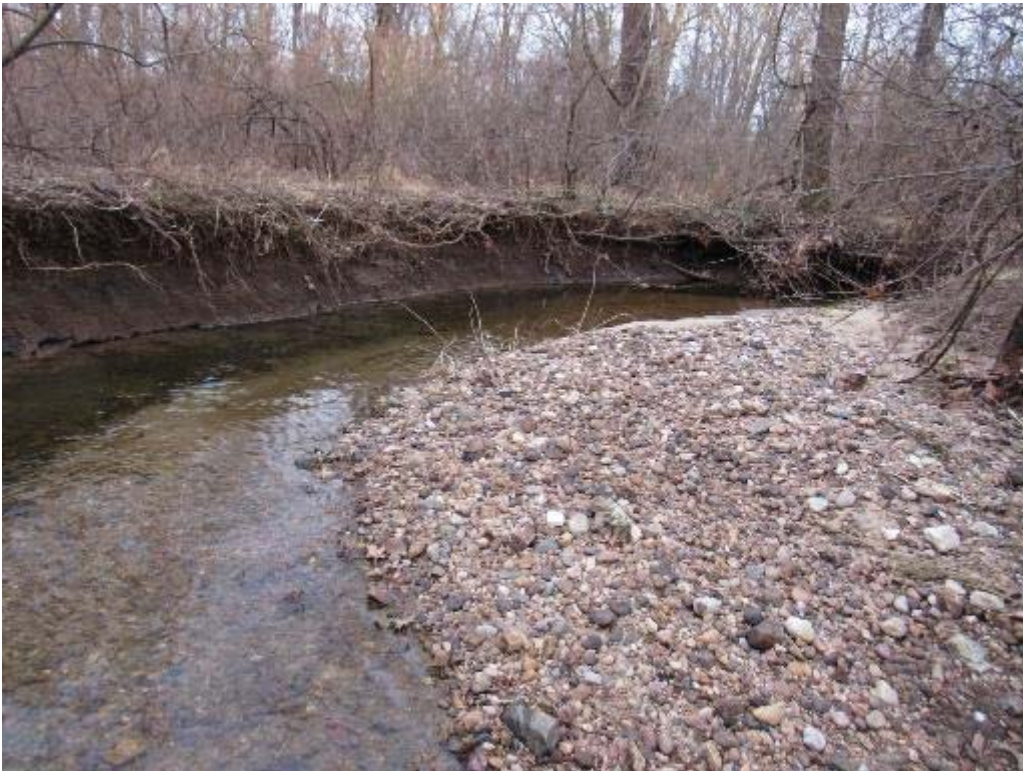
Photo 6 View looking downstream showing channel migration. The stream bank is vertical with exposed fine grained soil and excessive new gravel deposition on the inside of the meander. Lack of woody Riparian vegetation.

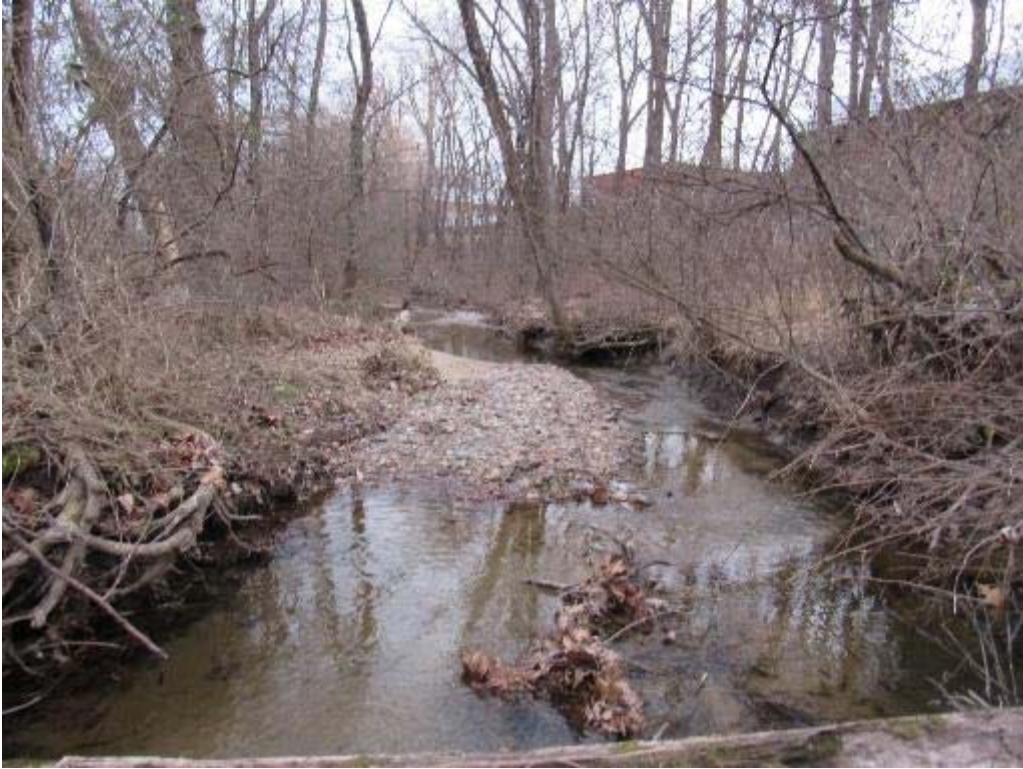
Photo 7 View looking downstream at undermined and leaning trees, fine grained sediment on channel bottom and excessive side gravel bar development.

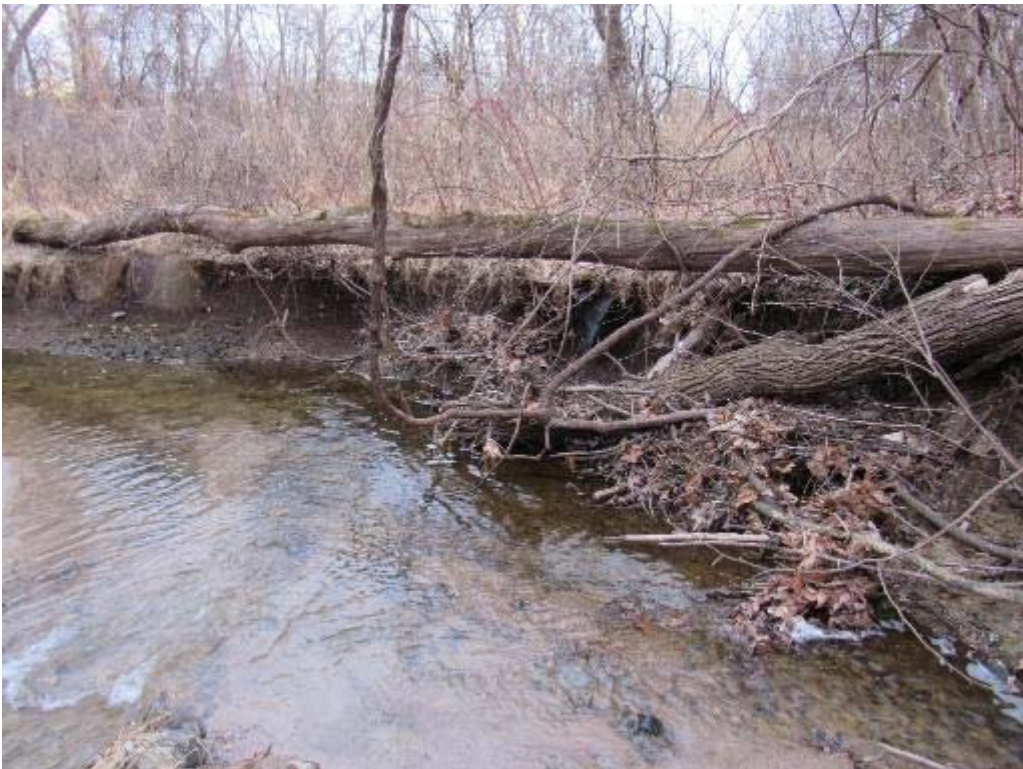
Photo 8 view looking at eroded channel meander bend an no woody riparian vegetation.

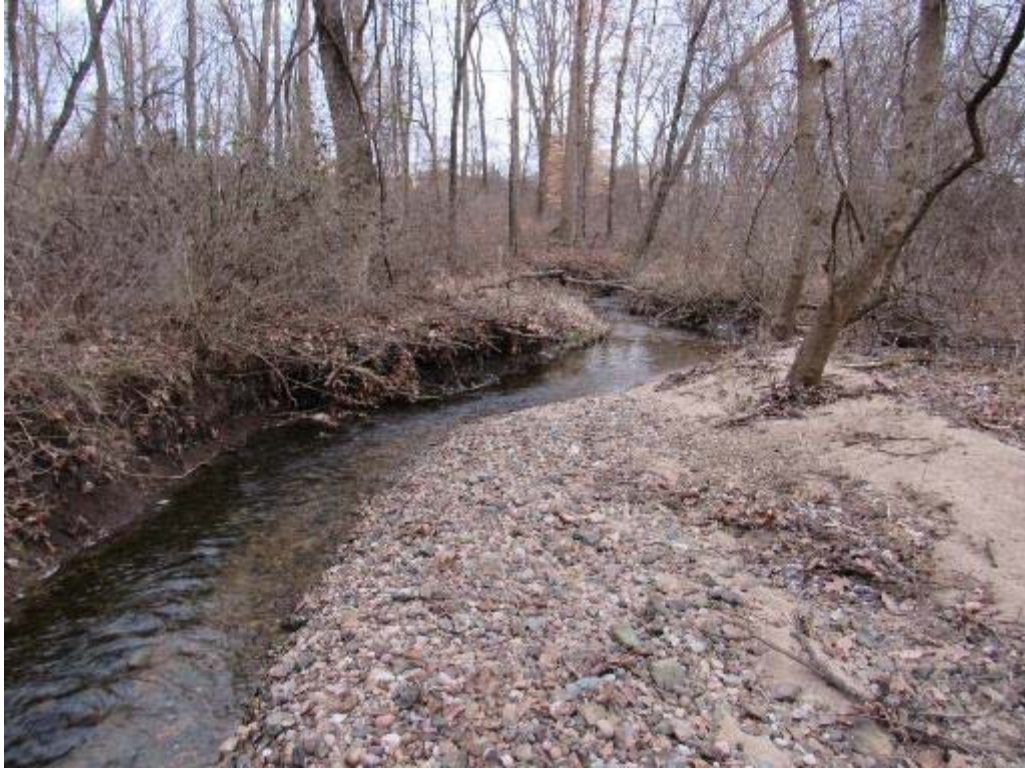
Photo 9 View looking downstream at bank erosion and active channel migration.

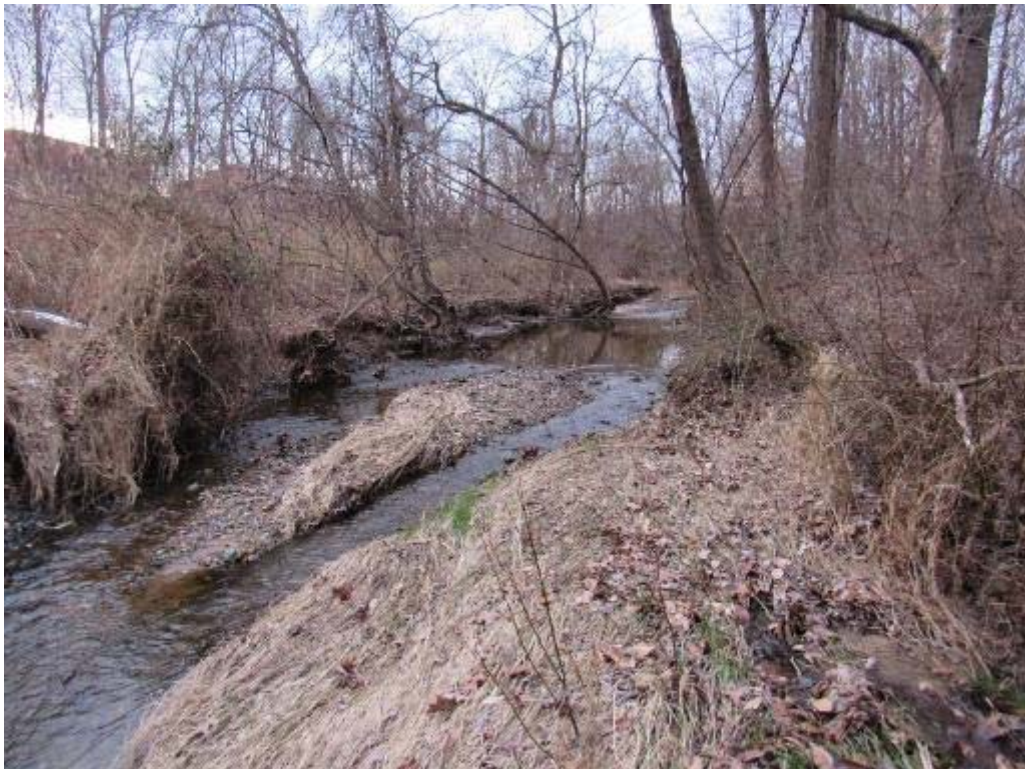
Photo 10 View looking upstream at eroded stream banks, channel widening and mid channel gravel bar development

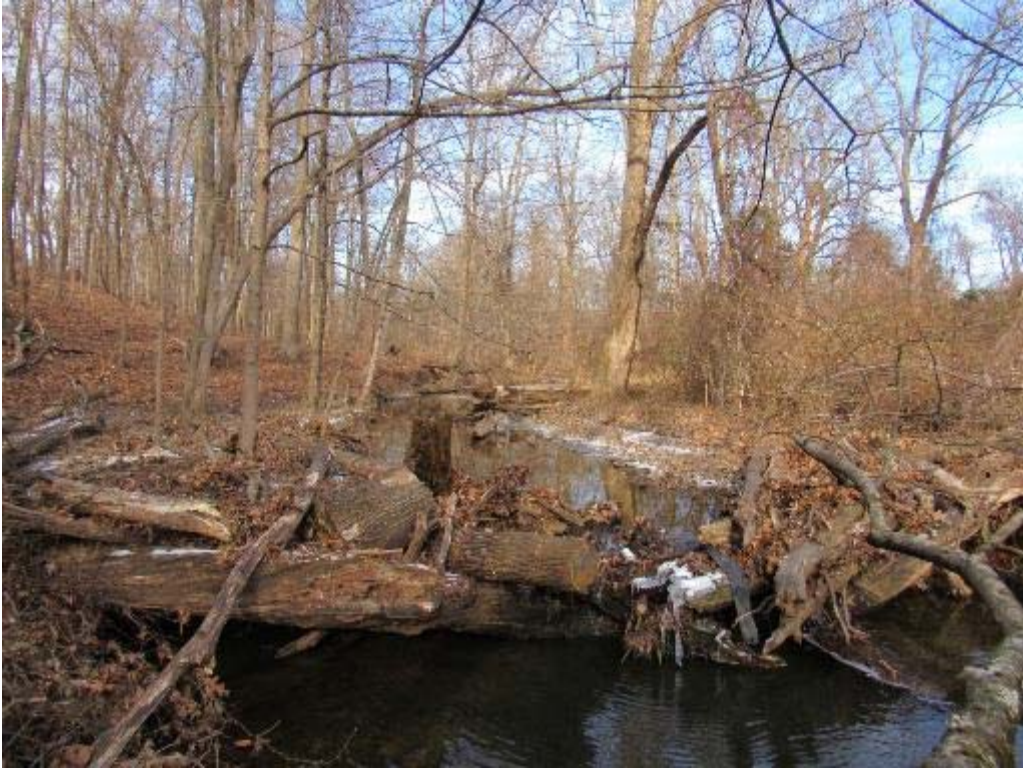
Photo 11 View looking upstream at large wood debris jam which provides grade control and enhances upstream floodplain connectivity. Restoration should incorporate more long term grade control to maintain upstream floodplain connectivity.

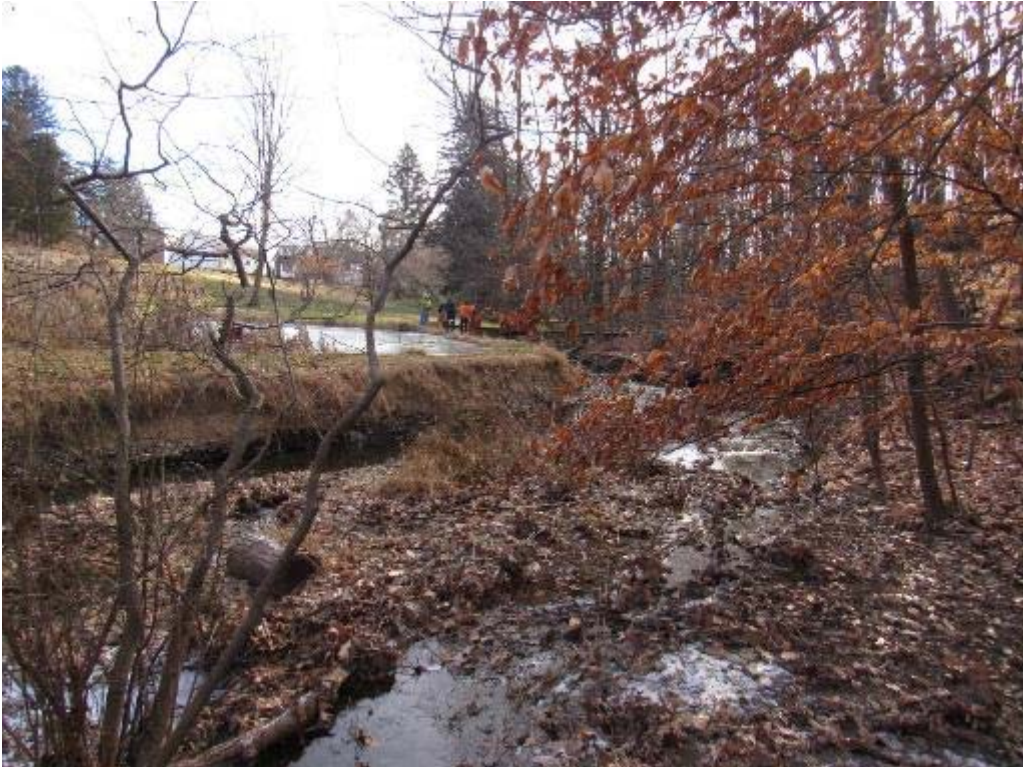
Photo 12 View looking downstream of log debris jam. The channel becomes more entrenched. Note vertical stream, eroded eastern stream and mid channel bar.

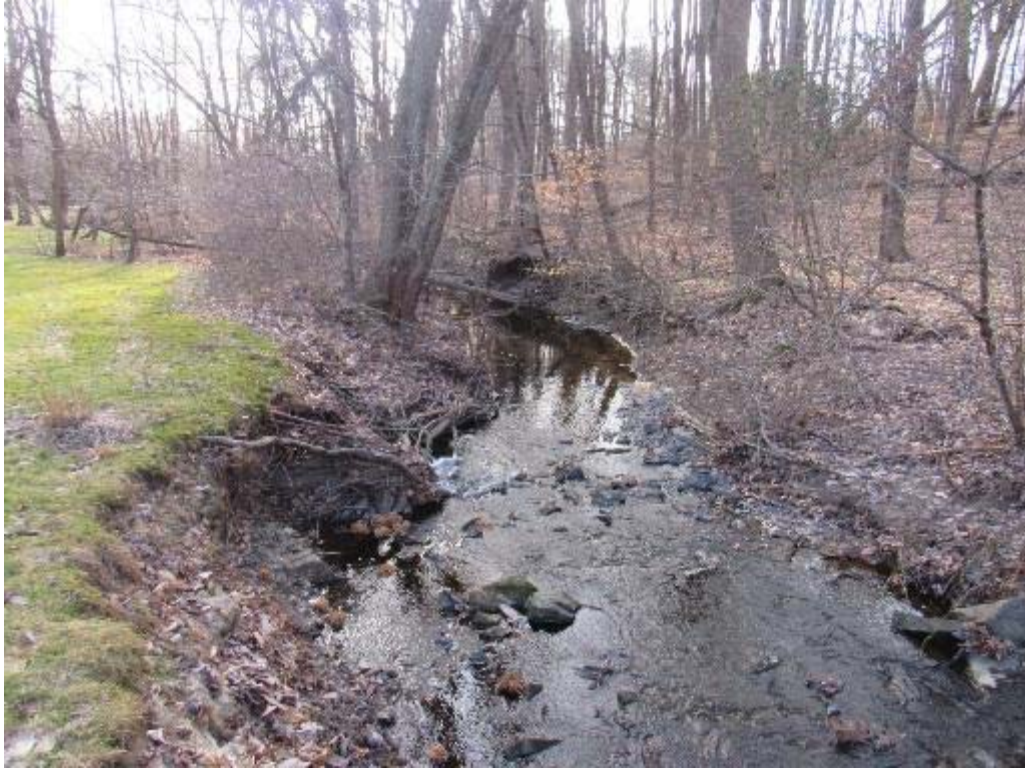
Photo 13 View looking downstream approximately 350 feet upstream of Turk Road. The channel is cut to bedrock with eroding stream banks and no floodplain access

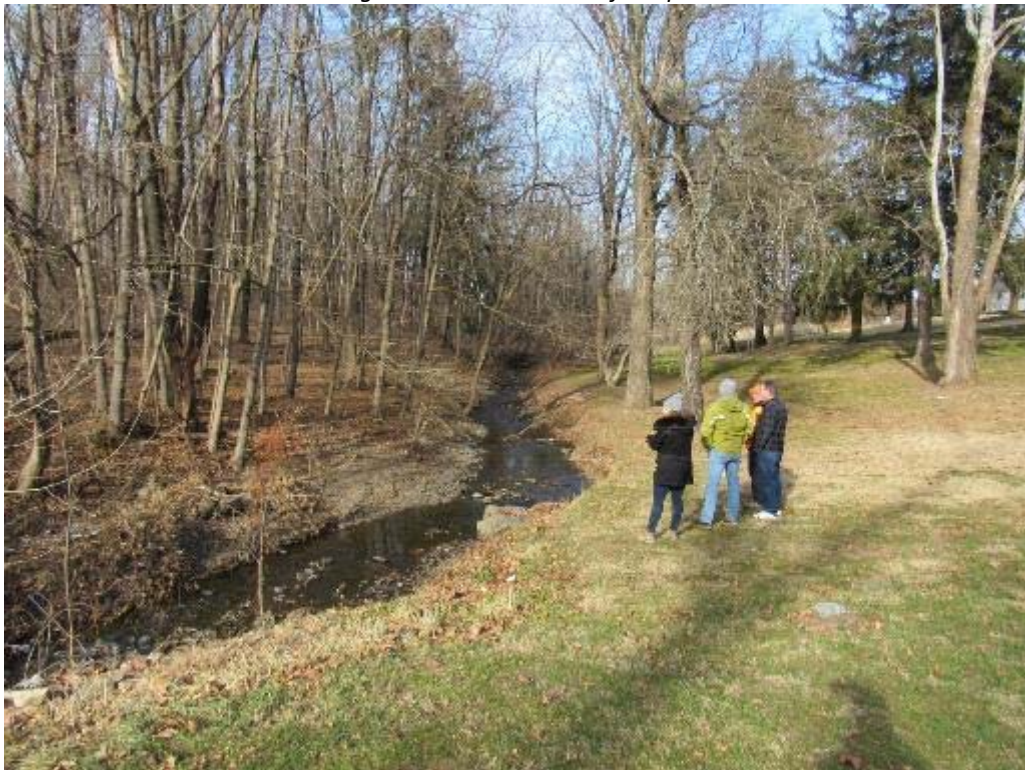
Photo 14 View looking upstream from Turk Road. The channel has cut down to bedrock with eroding stream banks.

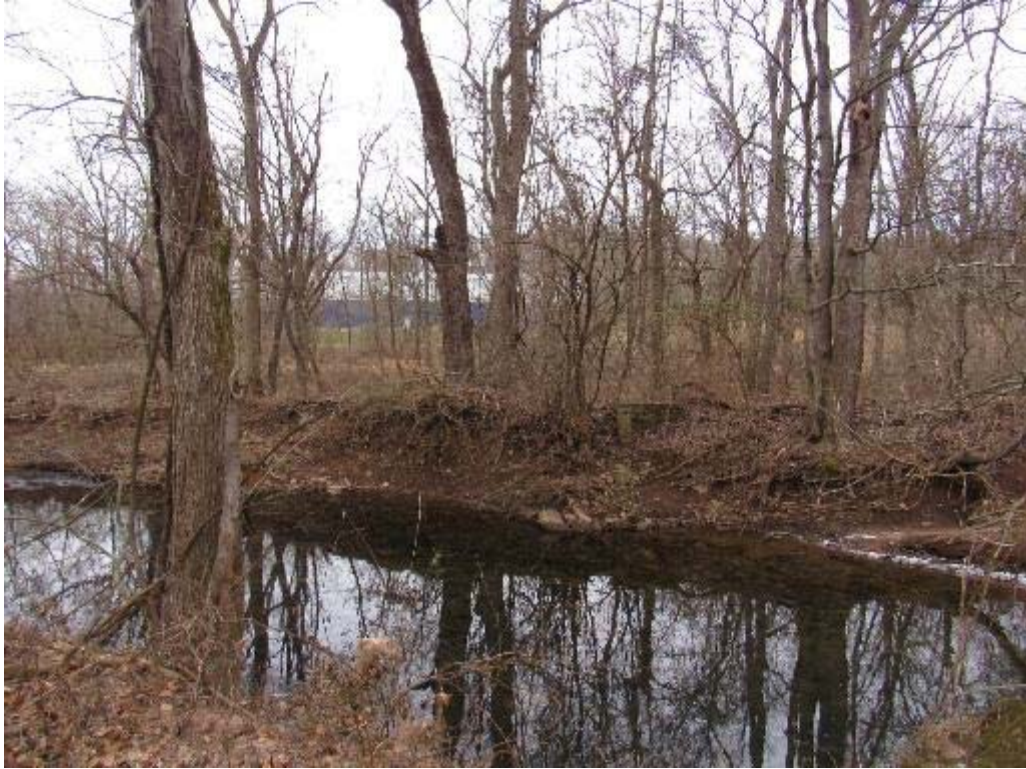
Photo 1- View looking north across Pine Run showing eroded stream bank and exposed tree roots.

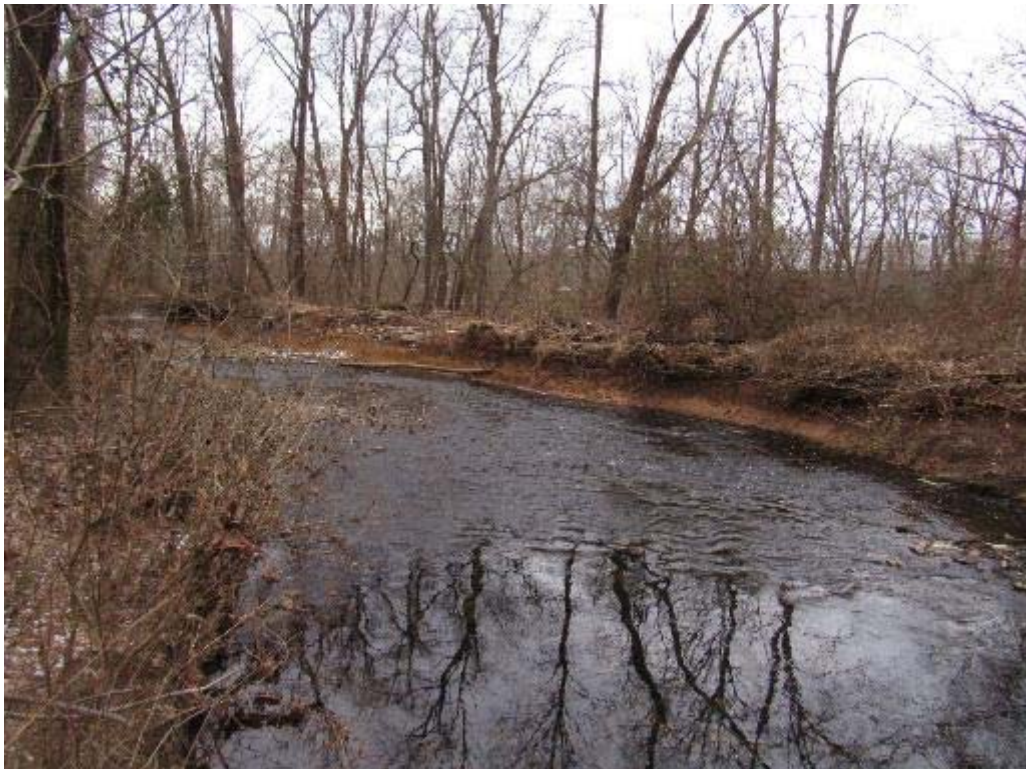
Photo 2- view looking downstream showing near vertical and eroding stream banks.

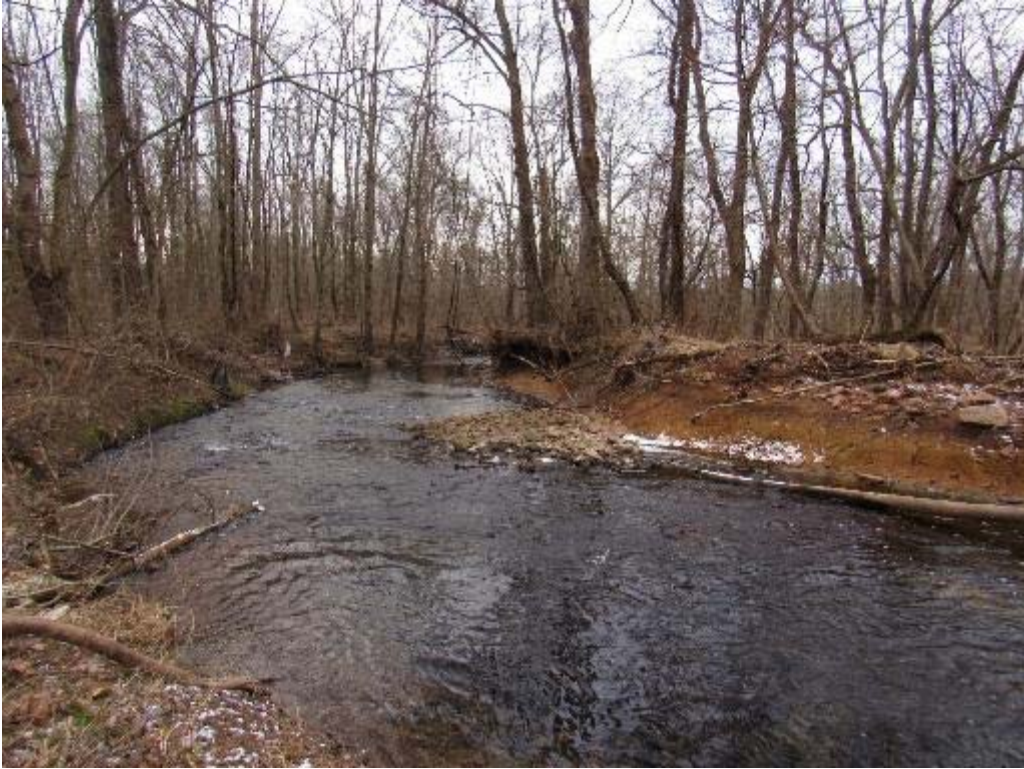
Photo 3- View looking downstream showing bank erosion

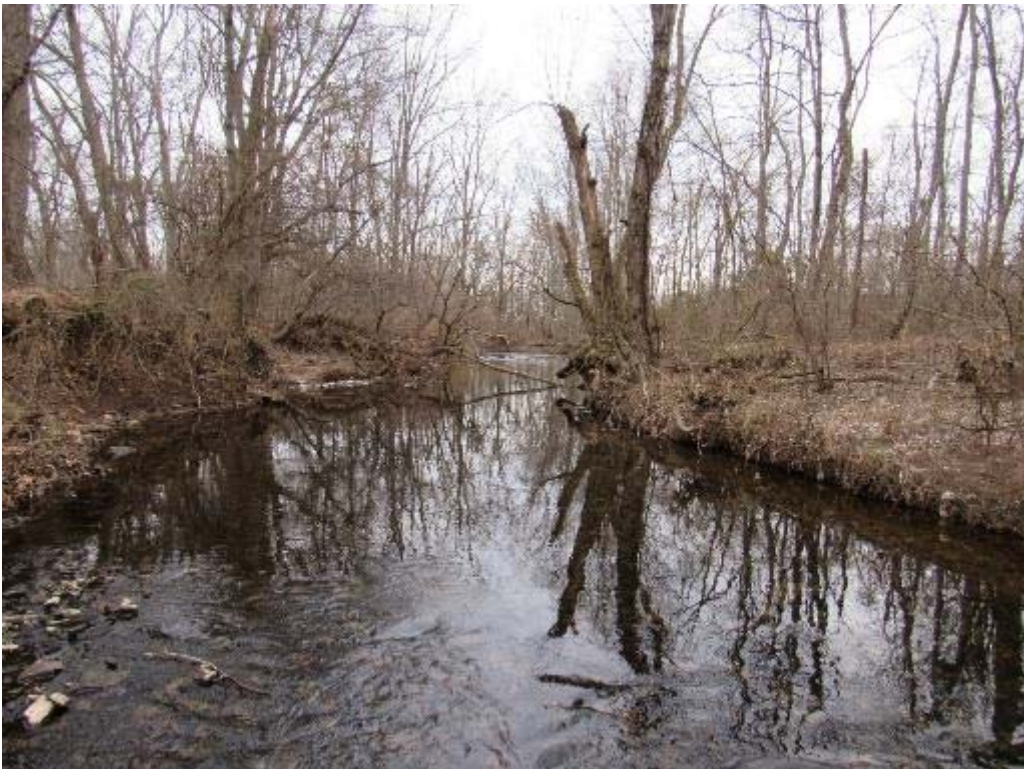
Photo 4- View looking upstream showing steeply sloping, eroding stream bank on the left with a stable lower bank and floodplain on the right.

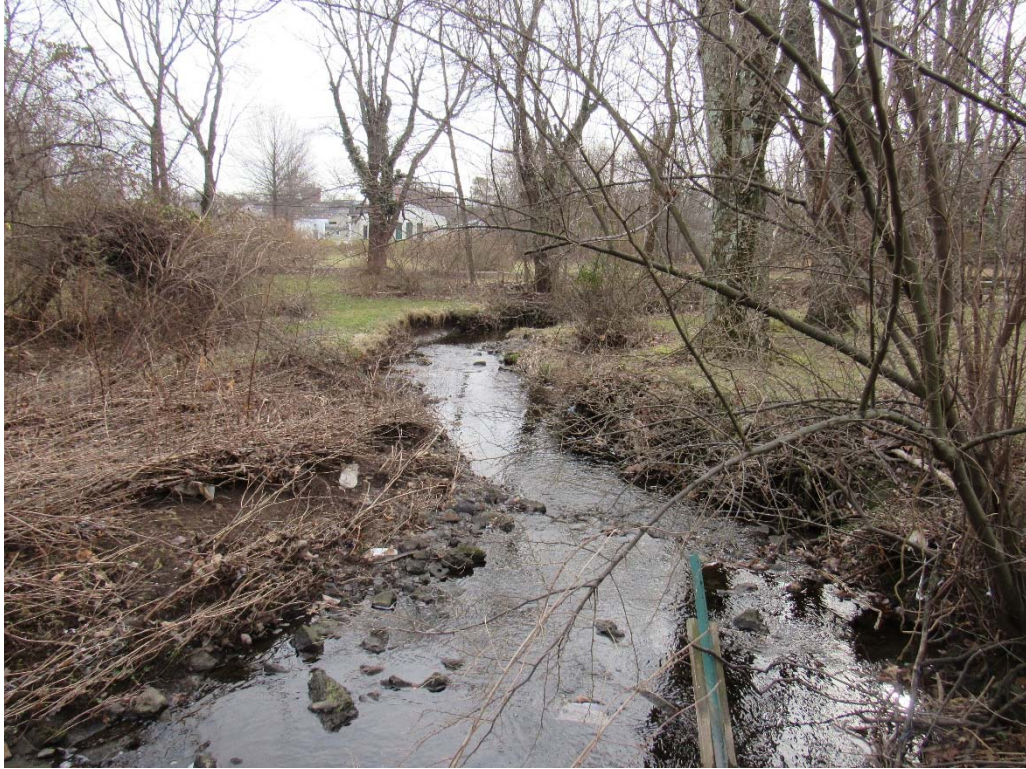
Photo 1 view looking downstream at vertical eroding stream banks and limited riparian vegetation

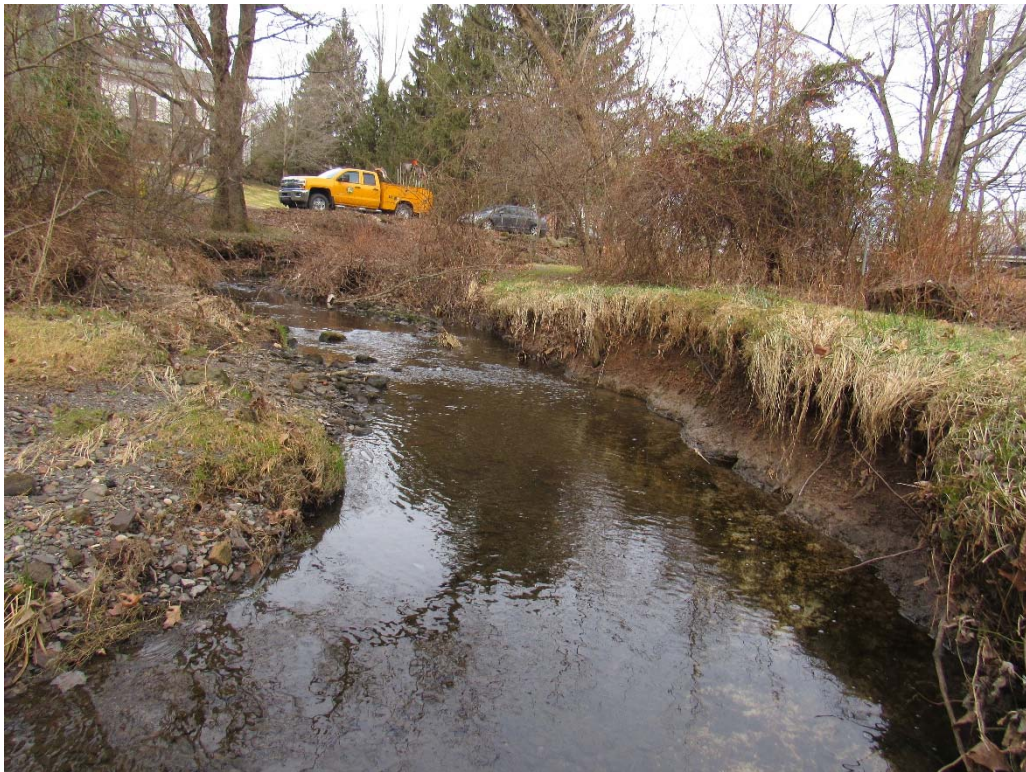
Photo 2 View looking upstream at eroding stream bank. The stream is slightly entrenched and could benefit from minor channel adjustments to provide better floodplain connection.

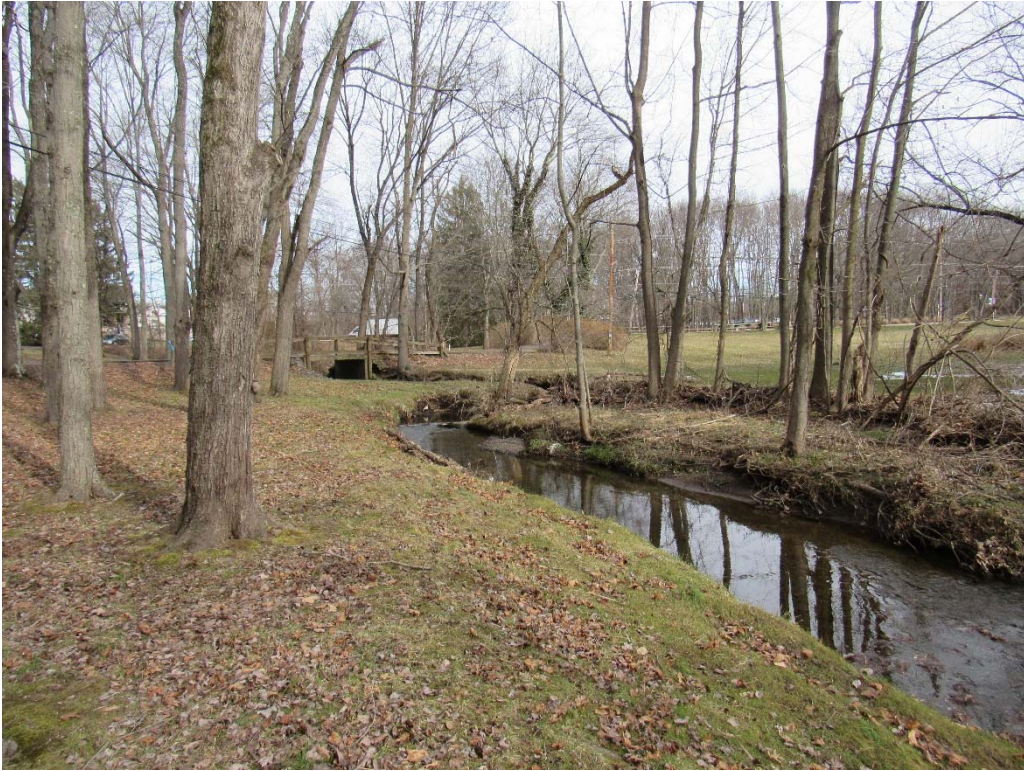
Photo 3 View looking upstream showing bank erosion and exposed tree roots. The riparian zone is currently mowed to the top of stream banks.

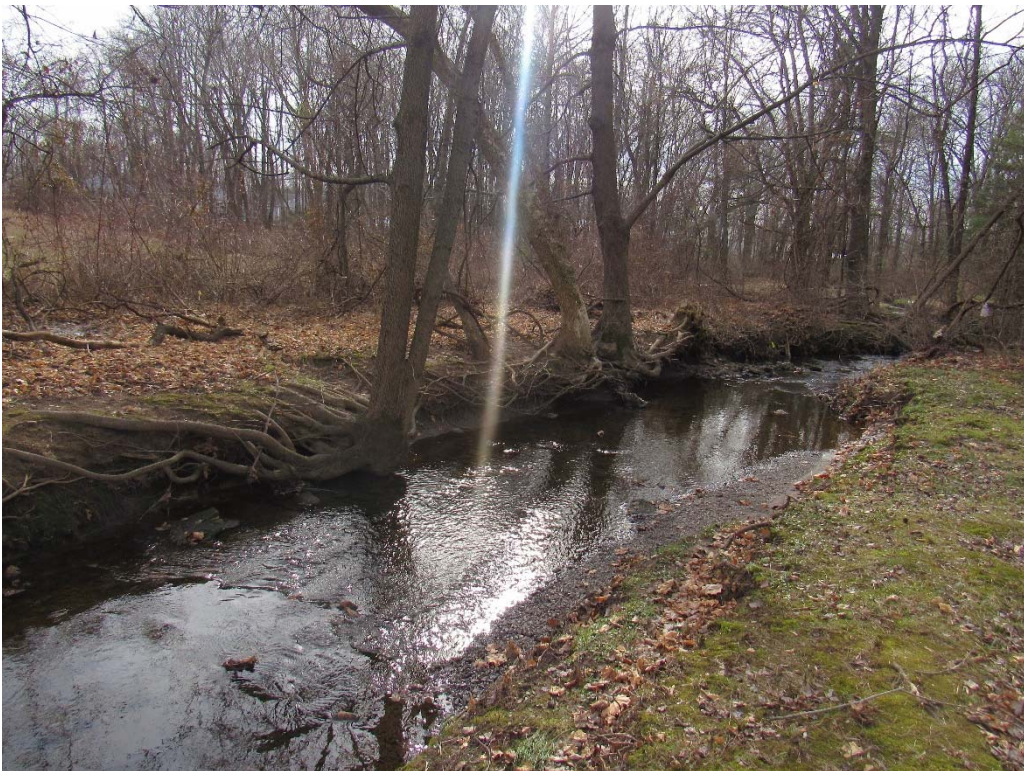
Photo 4 View looking downstream showing undermined trees and bank erosion.

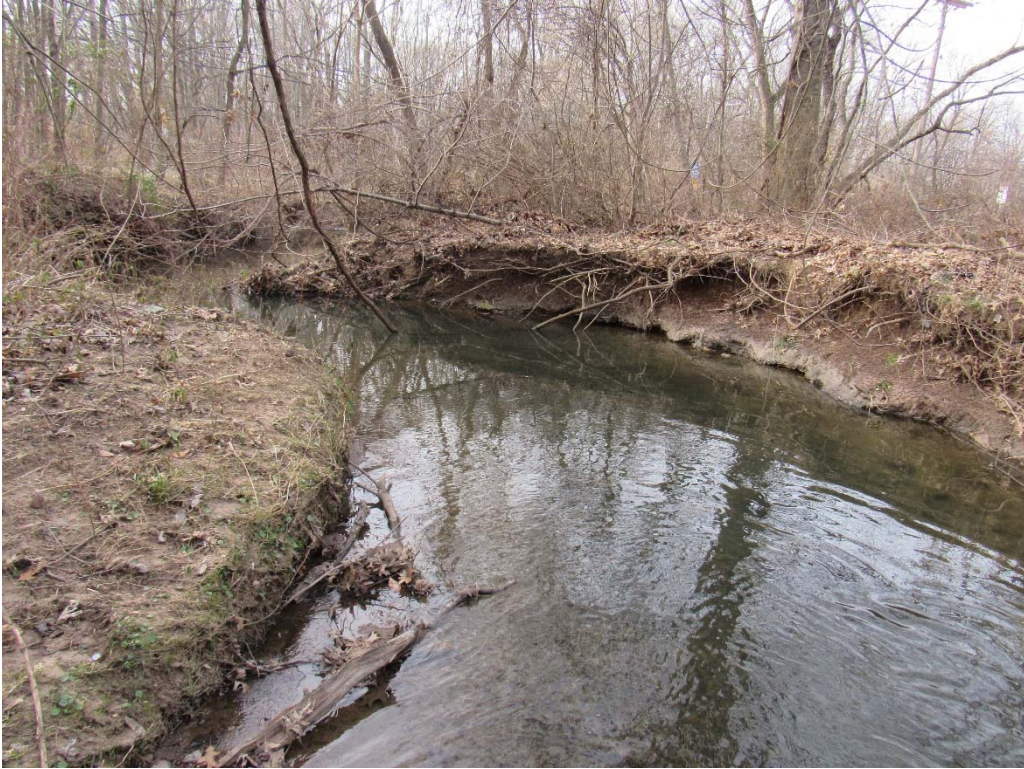
Photo 5 View looking downstream at eroded stream banks. There appears to be some limited connection to floodplain along the reach.

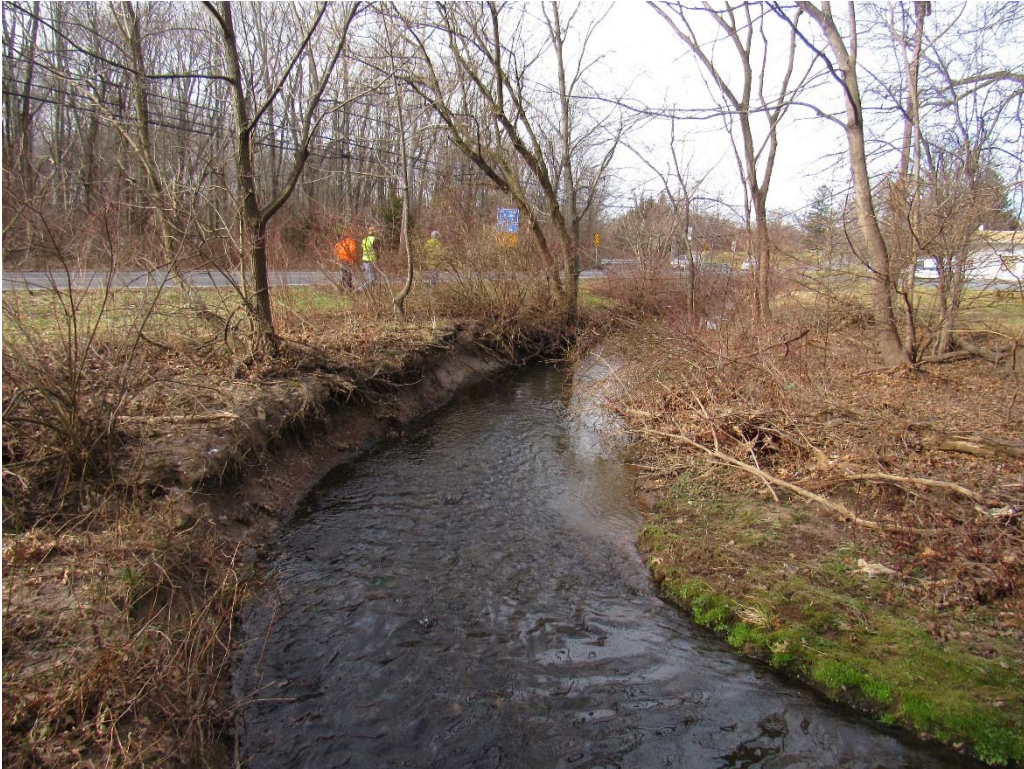
Photo 6 View looking downstream where Cooks run flow just north and parallel to Limekiln Road for 180 feet. Stream bank erosion is present along the south side of the channel.

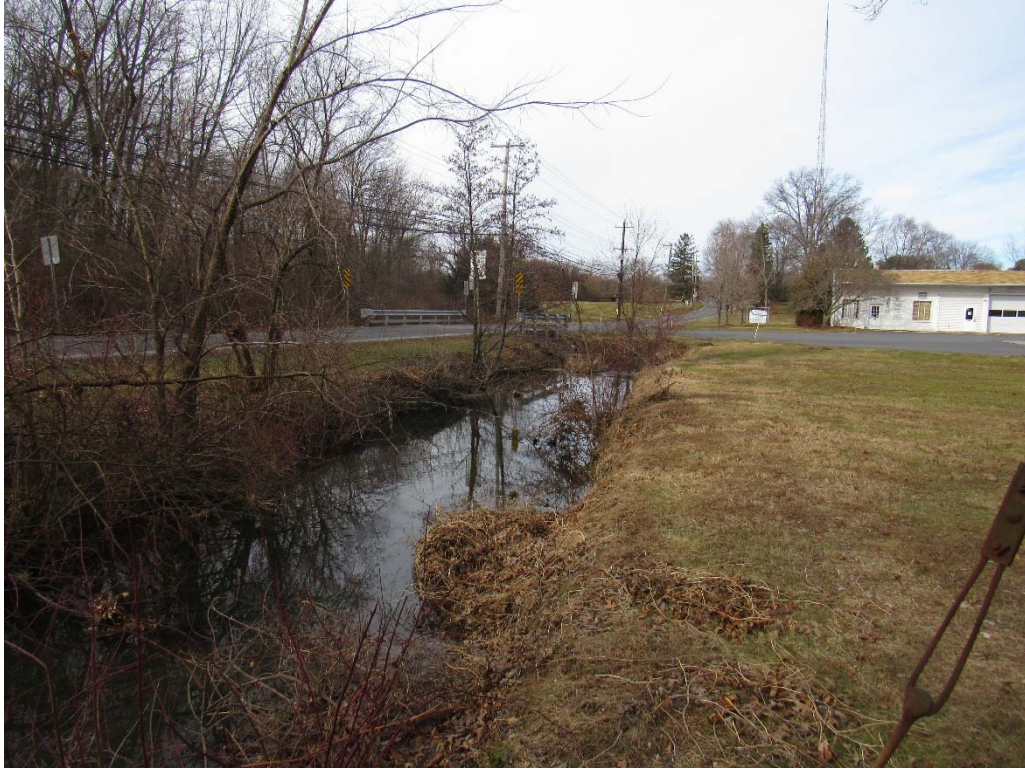
Photo 7 View looking downstream. The channel is entrenched with bank erosion along the left bank and a mowed riparian zone on the right bank.

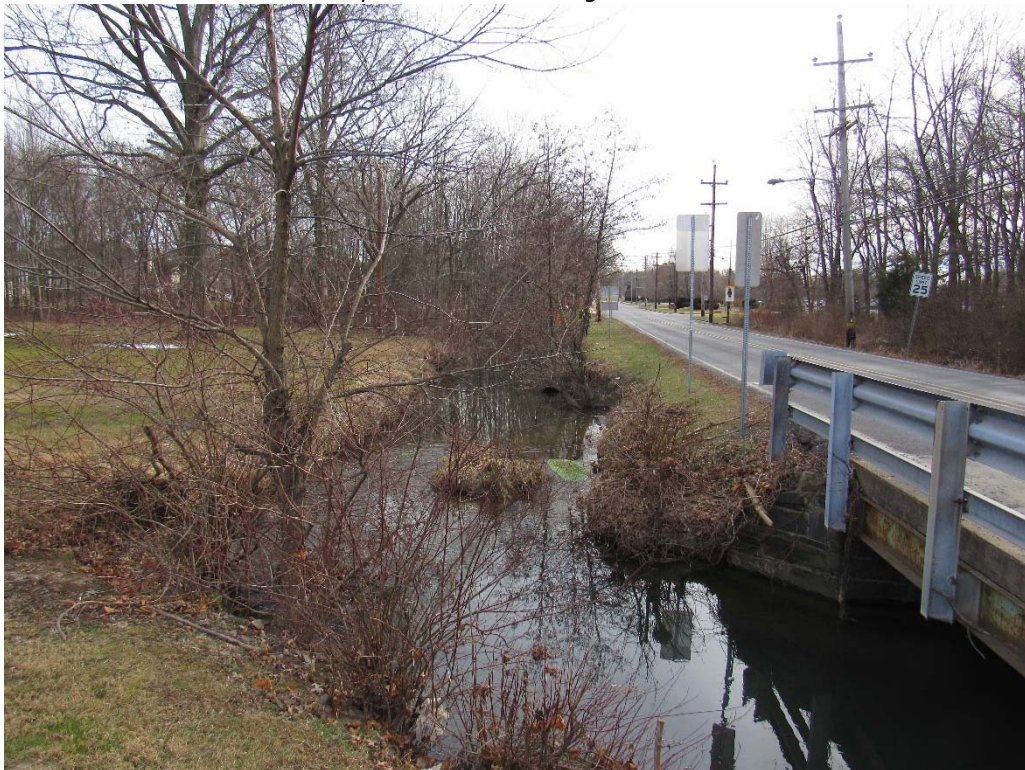
Photo 8 View looking upstream from Limekiln Road bridge. The area on the left side could be excavated to create a better floodplain connection. Limited opportunity exists for riparian zone enhancement along the south side of the channel due to required ROW restrictions

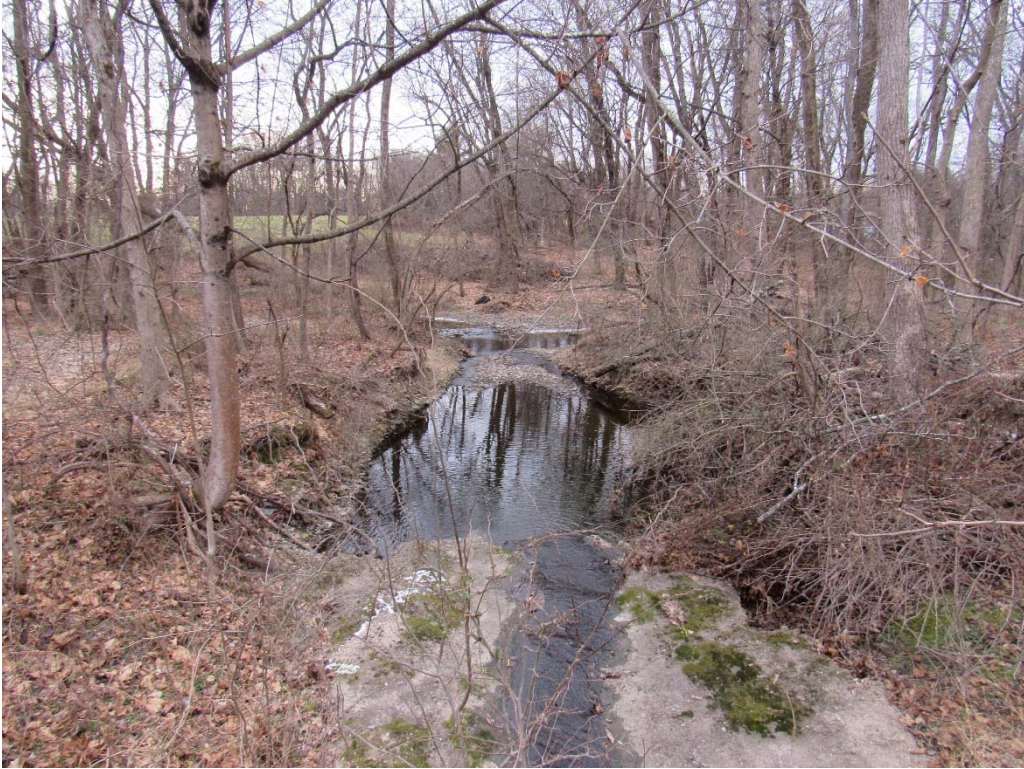
Photo 1 View looking downstream at eroded stream banks

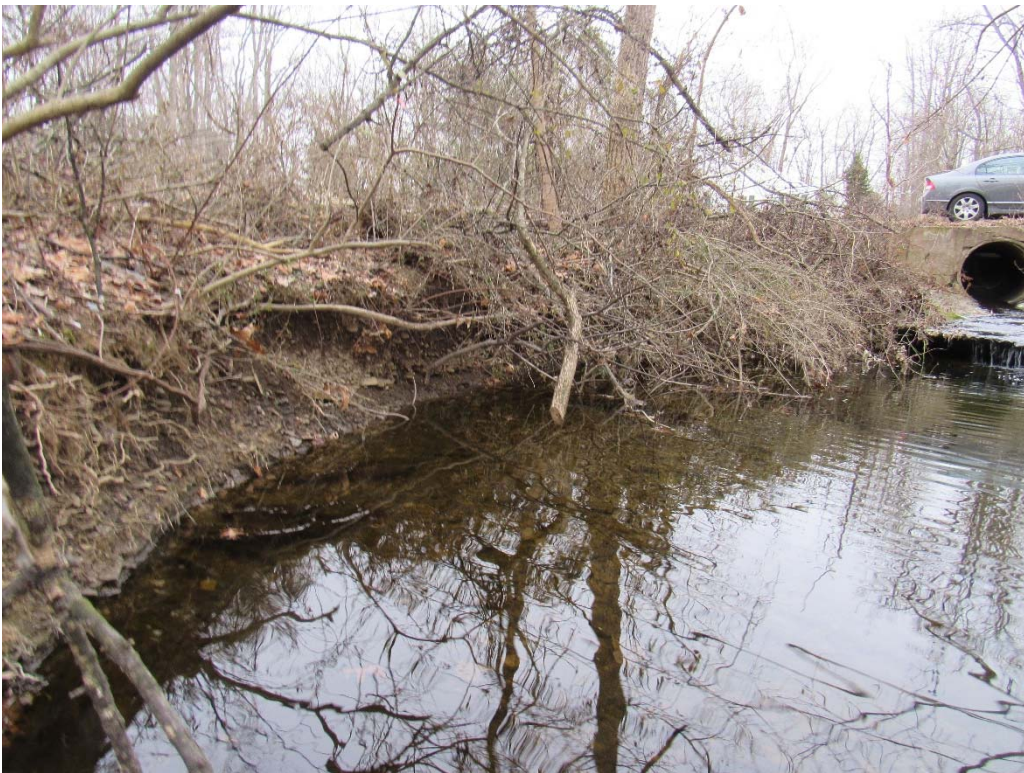
Photo 2 View looking upstream showing eroded stream bank and undermined concrete splash apron
