**Doylestown Township Pollutant Reduction Plan/TMDL Plan
Attachment D-2 - Structural BMPs to be Utilized to Reduce Existing Loading**

Attachment E-1

Photographs – Selected BMPs

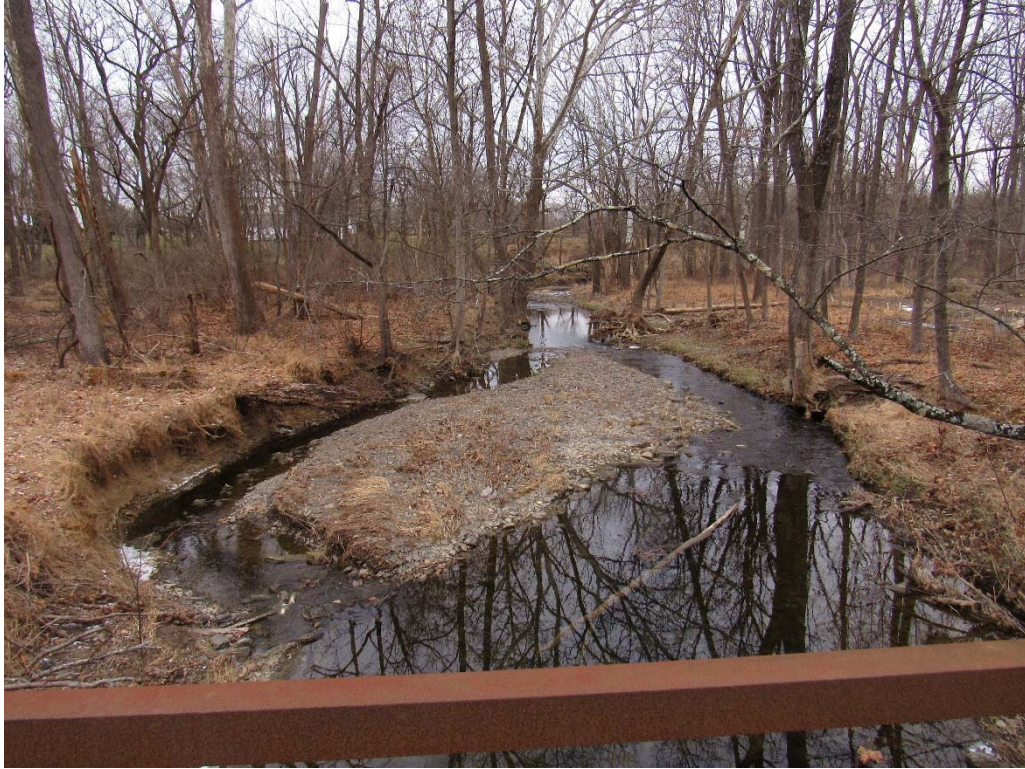
Photo 3 View looking downstream showing mid channel gravel bar development, channel widening and stream bank erosion

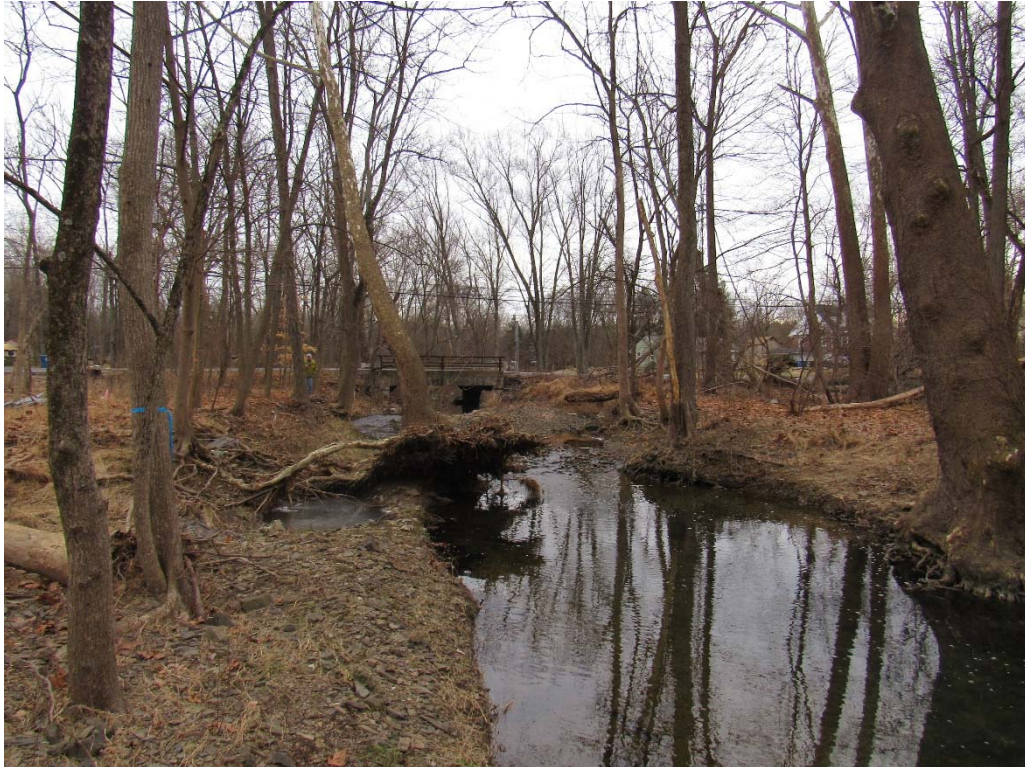
Photo 4 View looking upstream towards bridge showing channel widening, bank erosion and uprooted mature trees
